# Manhole Inspection Summary

Manhole # S25EE1020MH

Insp Date: **4/10/07 11:41 AM**

**Location** Address: **1100 38TH ST**

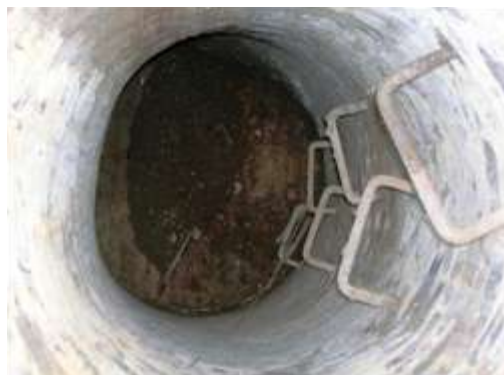
Top View

Corroded steps. Channel debris.

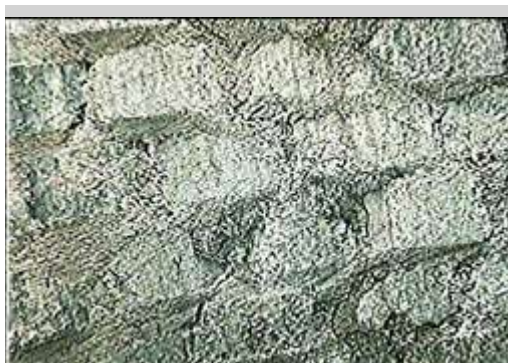
Defect

Barrel deterioration and infiltration.

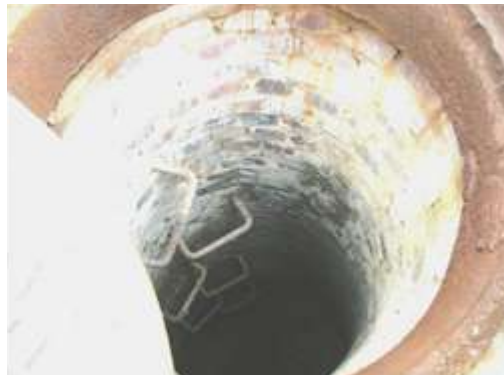
Defect

Frame leaks. Adjustment deterioration. Adjustment, Corbel, and Barrel infiltration - other side.

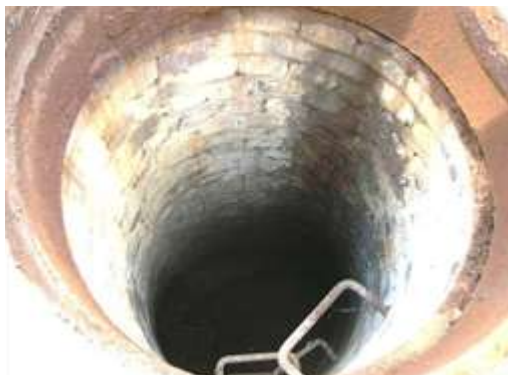
Defect

Frame leaks. Adjustment deterioration. Adjustment, Corbel, and Barrel infiltration.

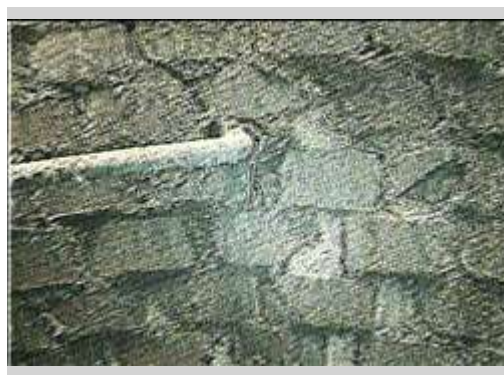
Defect

Corbel deterioration and infiltration.

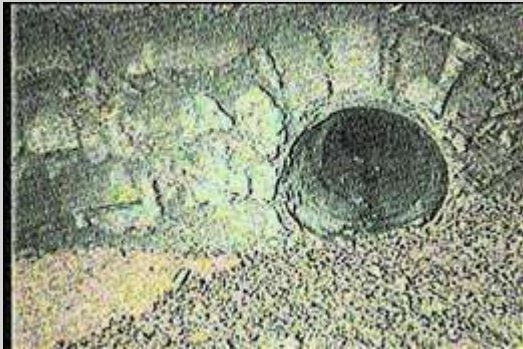
8 in. Circular Gravity Sewer  
Pipe Out @ 12 O'Clock

Deposits: ☐ None ☒ **Mud** ☐ Sludge ☒ **Debris** ☒ **Grease**

Silt Depth: **0.5** (in.) Deposits Extent: **Light**

Infiltration: **Evidence** Pipe Seal Cond: **Cracked**
